VUF-1015
FINAL REPORT

VELA UNIFORM PROJECT SHOAL

PRESHOT AND POSTSHOT STRUCTURE SURVEY
Holmes & Narver, Inc.

December 1963

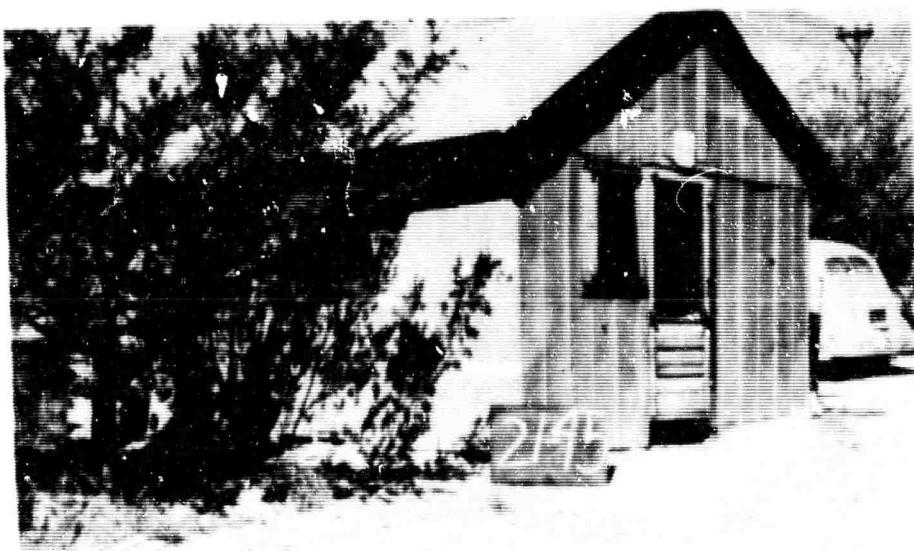
Photo No. 21-45 - Preshot - October 2, 1963

21-45 Residence (See photo 21-45) This is a 12 x 15-foot residence of wood frame and corrugated metal siding. AZ 250° clockwise from magnetic north. No damage was noted as a result of the postshot survey.

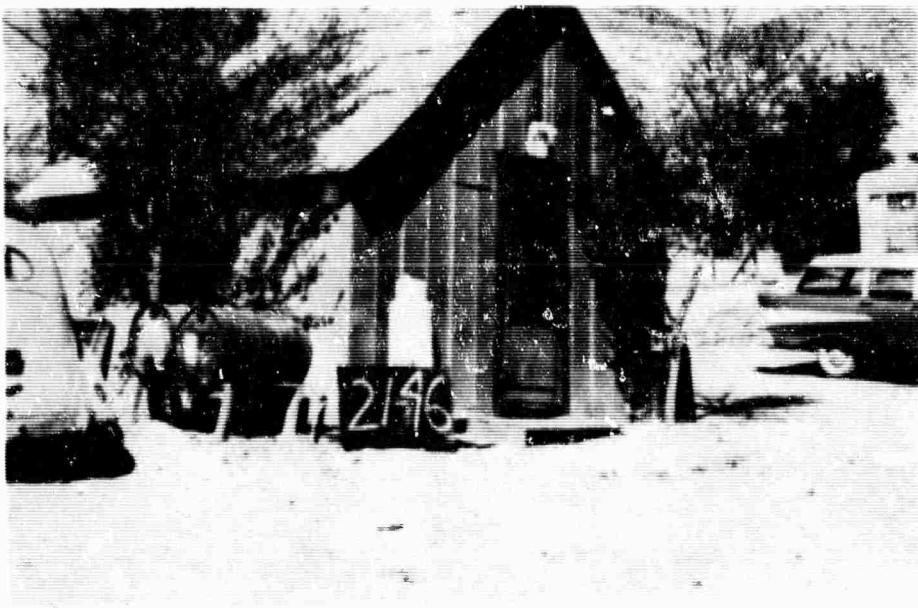
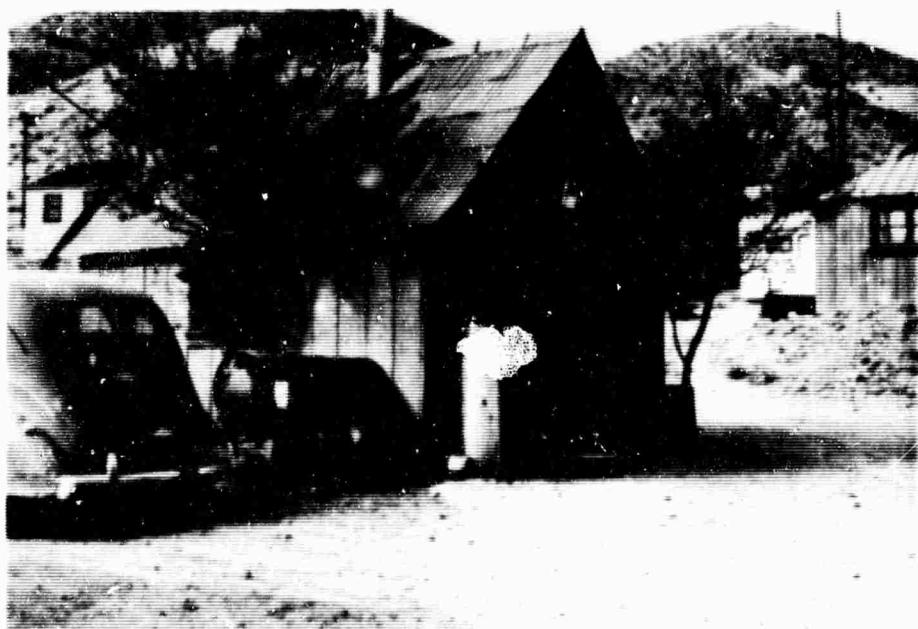
Photo No. 21-46 - Preshot - October 2, 1963

21-46 Residence (See photo 21-46) This is a 12 x 15-foot residence of wood frame and metal siding. AZ 250° clockwise from magnetic north. No damage was noted as a result of the postshot survey.

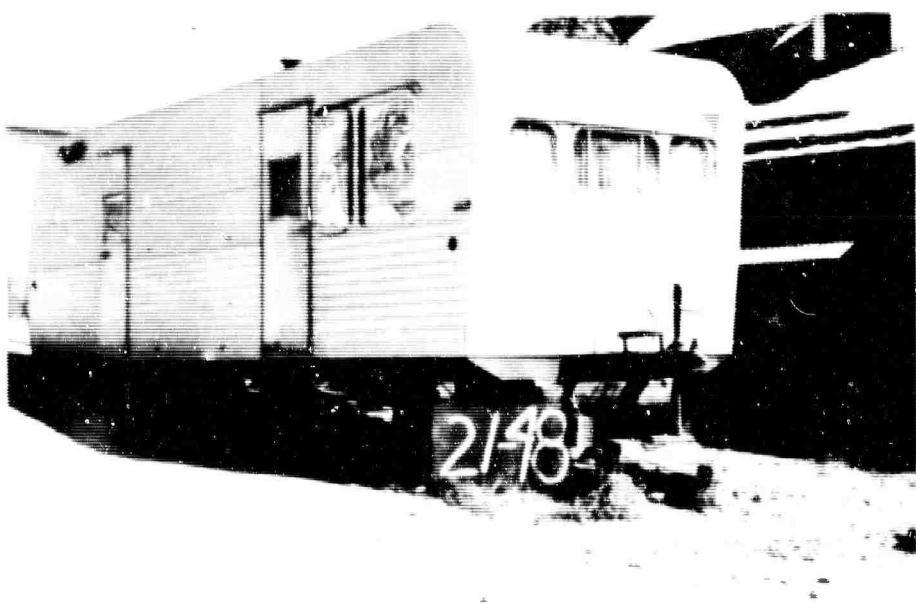
Photo No. 21-48 - Preshot - October 2, 1963

21-48 Trailer (See photo 21-48) This is a 25 x 8-foot metal covered trailer. AZ 85° clockwise from magnetic north. No damage was noted as a result of the postshot survey.

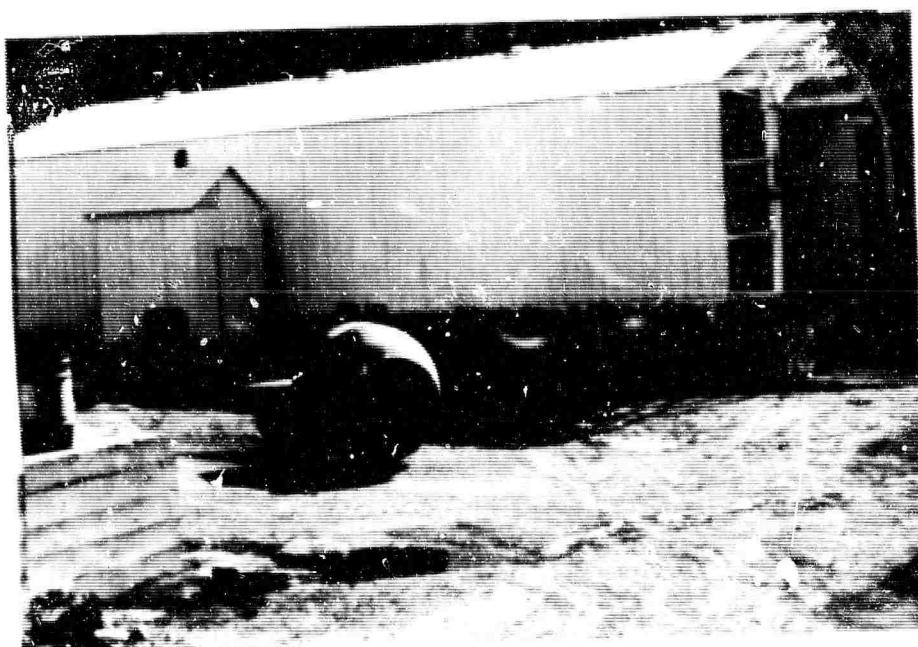
Photo No. 21-51 - Preshot - October 8, 1963

21-51 New Acid Plant (See photo 21-51) The main building is a 36 x 72-foot steel rigid frame with metal siding. (Butler type building). The 10 x 10-foot electrical building is wood frame with metal siding. New acid plant now under construction. AZ 70° clockwise from magnetic north. No damage was noted as a result of the postshot survey.

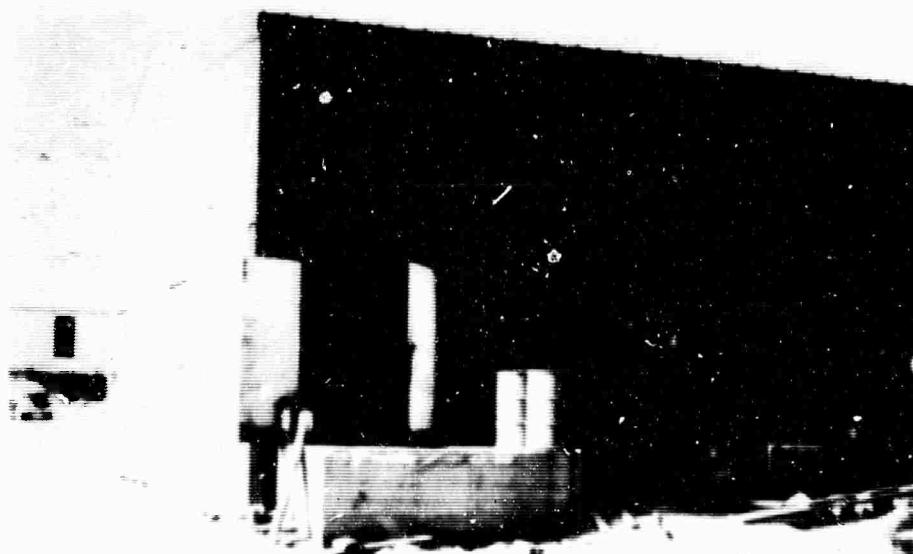
Photo No. 21-52 - Preshot - October 8, 1963

21-52 Assay, Testing and Storage (See photo 21-52) The building is a 36 x 44-foot steel rigid frame with metal siding, used as an assay lab and physical testing and storage building. AZ 290° clockwise from magnetic north. No damage was noted as a result of the postshot survey.

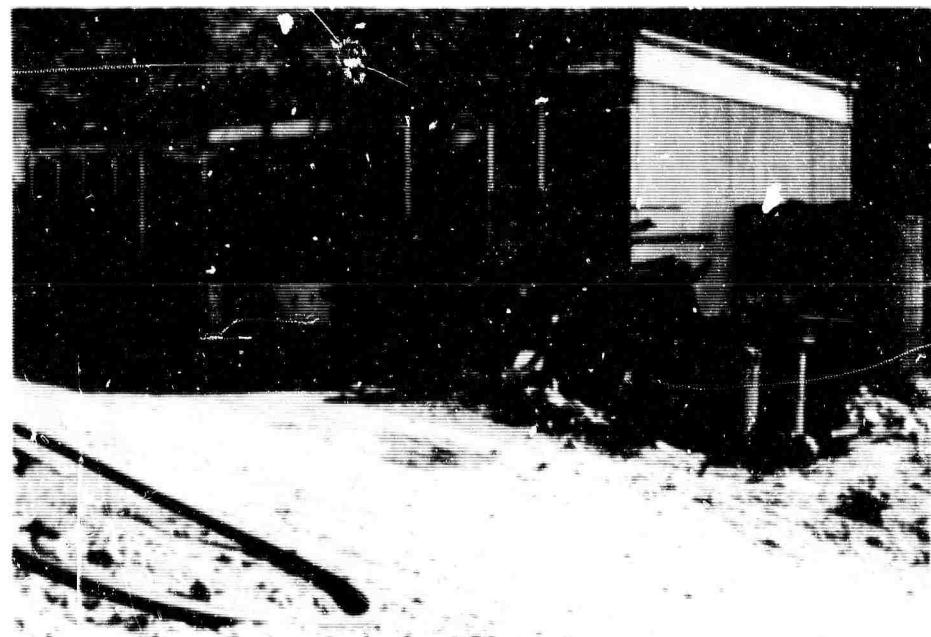
Photo No. 21-56 - Preshot - October 8, 1963

21-56 Warehouse (See photo 21-56) This 20 x 34-foot warehouse is all metal with glass front. AZ 80° clockwise from magnetic north. No damage was noted as a result of the postshot survey.

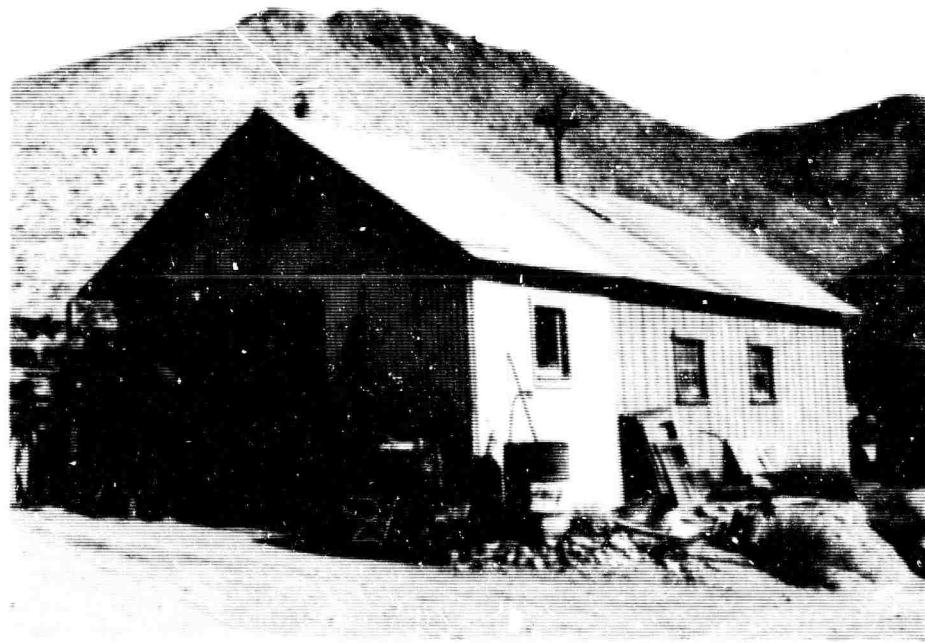
Photo No. 21-58 - Preshot - October 8, 1963

21-58 Carpentry Shop (See photo 21-58) Building is a 14 x 36-foot wood frame and metal-siding structure used as carpentry shed. AZ 30° clockwise from magnetic north. No damage was noted as a result of the postshot survey.

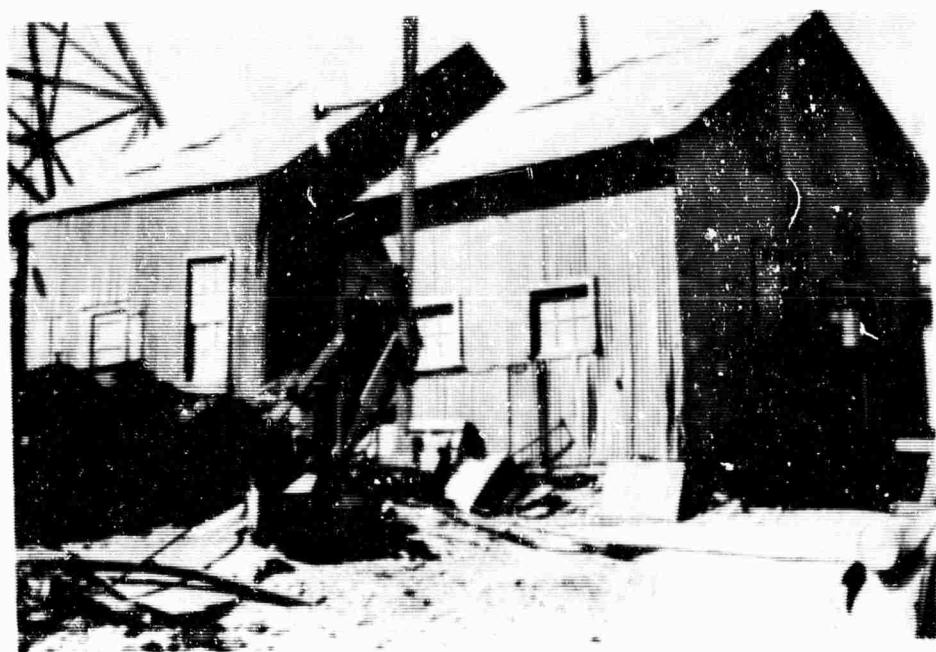
Photo No. 21-59 - Preshot - October 2, 1963

21-59 Hoist House (See photo 21-59) This hoist house is a 20 x 36-foot wood frame and corrugated metal-siding structure. AZ 210° clockwise from magnetic north. No damage was noted as a result of the postshot survey.

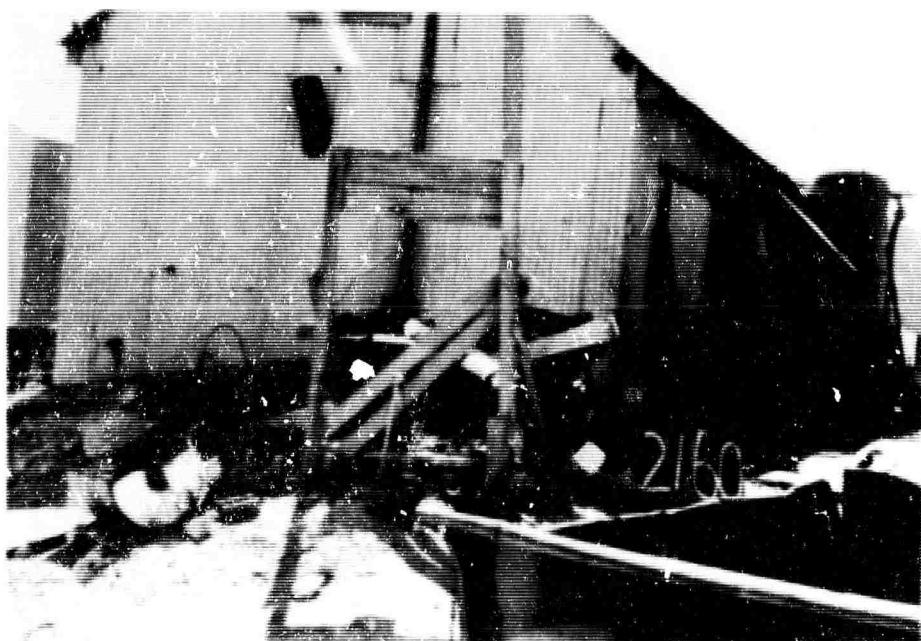
Photo No. 21-60 - Preshot - October 2, 1963

21-60 Blacksmith Shop (See photo 21-60) Building is a 14 x 48-foot blacksmith shop of wood frame and corrugated metal siding. AZ 195° clockwise from magnetic north. No damage was noted as a result of the postshot survey.

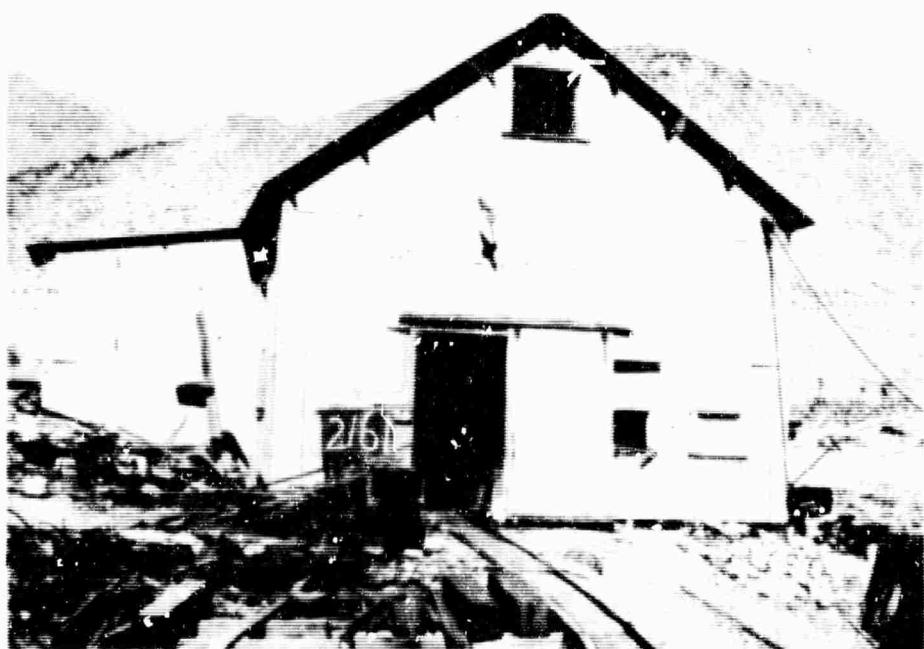
Photo No. 21-61 - Preshot - October 2, 1963

21-61 Timber Shed (See photo 21-61) This timber shed is a 22 x 48-foot wood frame and metal siding structure. AZ 350° clockwise from magnetic north. No damage was noted as a result of the postshot survey.

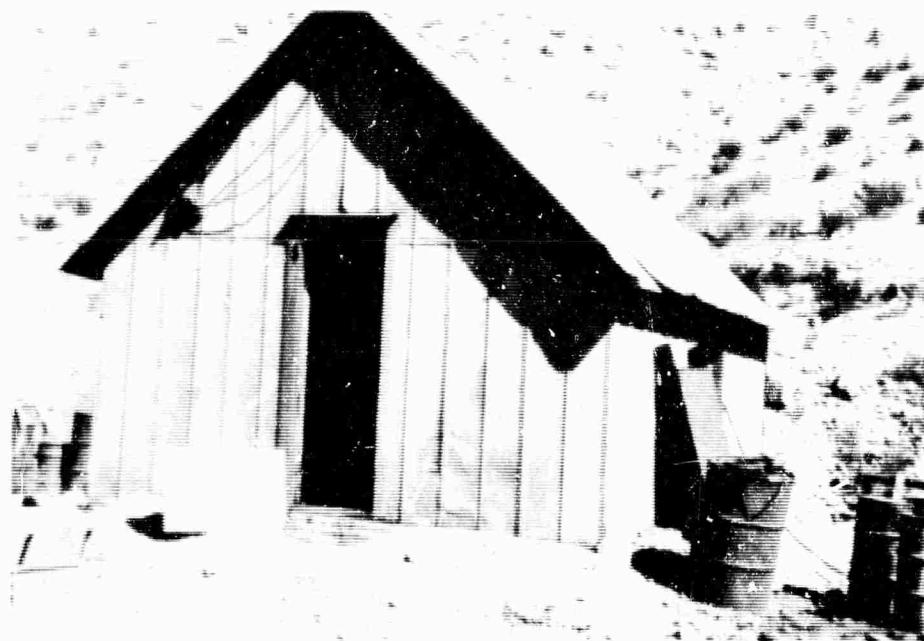
Photo No. 21-67 - Preshot - October 2, 1963

21-67 Work Shed (See photo 21-67) This is a 15 x 15-foot work shed of wood frame with metal siding. AZ 70° clockwise from magnetic north. No damage was noted as a result of the postshot survey.

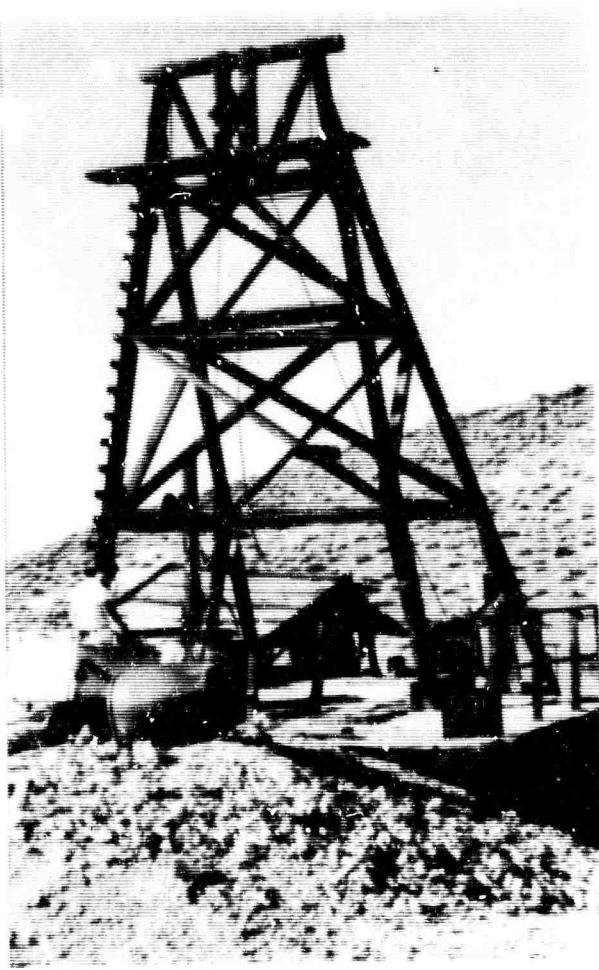
Photo No. 22-1

22-1 Headframe (See photo 22-1) Wooden headframe structure. Platform is warped and split. No damage was noted as a result of the postshot survey.

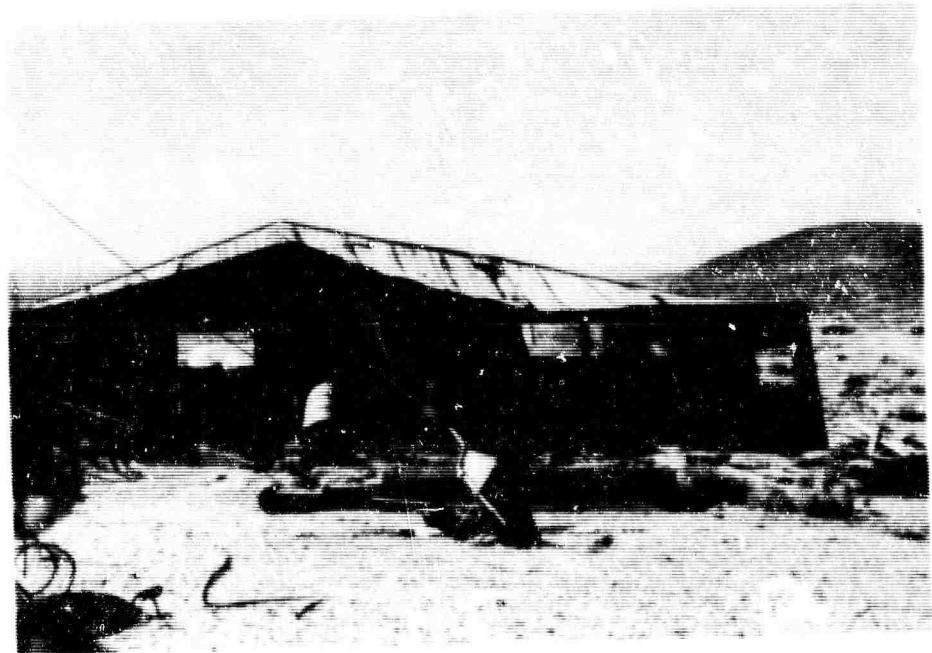
Photo No. 22-3 - Preshot - October 3, 1963

22-3 Shed (See photo 22-3) This shed is a 10 x 50-foot dilapidated wood structure. Walls are leaning and roof has sagged. Roofing, doors, windows and siding, in part, are missing. No damage was noted as a result of the postshot survey.

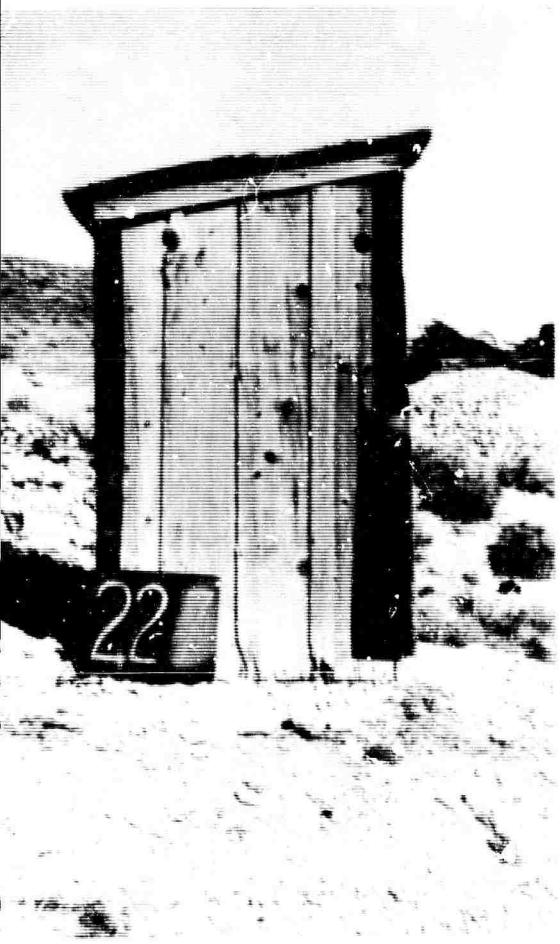
Photo No. 22-7

22-7 Outhouse (See photo 22-7) This 4 x 4-foot wooden outhouse is weathered but intact. No damage was noted as a result of the postshot survey.

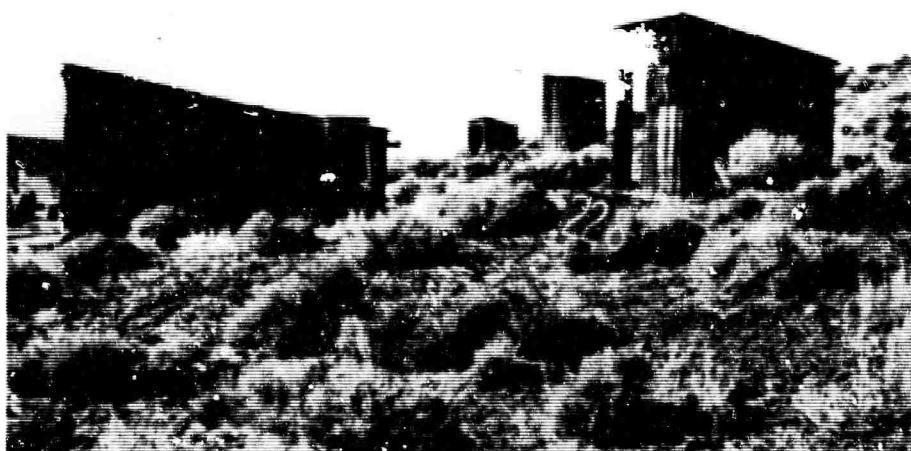
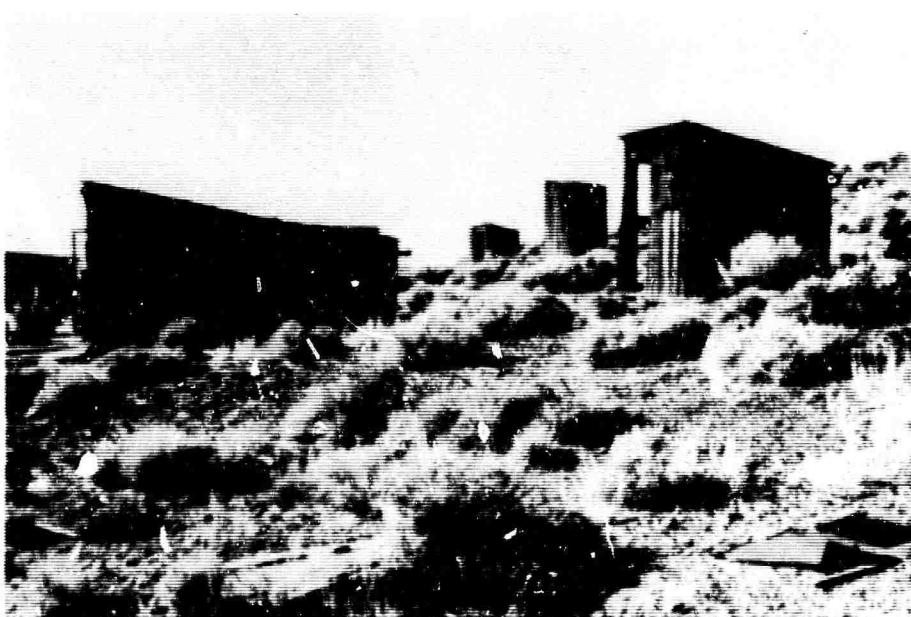
Photo No. 22-8 - Preshot - October 3, 1963

22-8 Shed (See photo 22-8) This 6 x 10-foot unoccupied wooden shed is in poor condition. Weathered and warped. Doors and windows missing. No damage was noted as a result of the postshot survey.

22-9 House (See photo 22-8) This 20 x 50-foot wood structure is partly occupied. In poor condition, with some doors and windows missing. No damage was noted as a result of the postshot survey.

22-10 Outhouse (See photo 22-8) This 3 x 5-foot outhouse is usable but weathered and warped. No damage was noted as a result of the postshot survey.

22-11 Outhouse (See photo 22-8) This 3 x 5-foot outhouse is leaning, weathered, and warped. Door missing. No damage was noted as a result of the postshot survey.

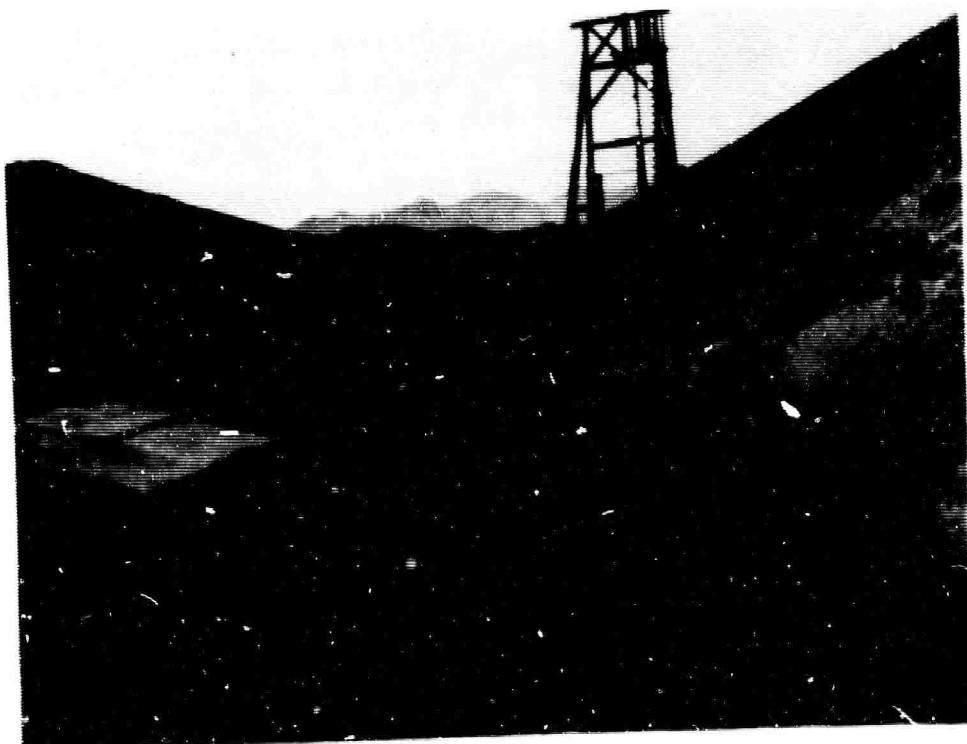
Photo No. 23-1 - Preshot - October 2, 1963

23-1 Headframe (See photo 23-1) Wood headframe, tramway, and ore bin. Weather-beaten and abandoned. Hoist house structure with roof missing. Siding warped and missing, and doors and windows missing. No damage was noted as a result of the postshot survey.

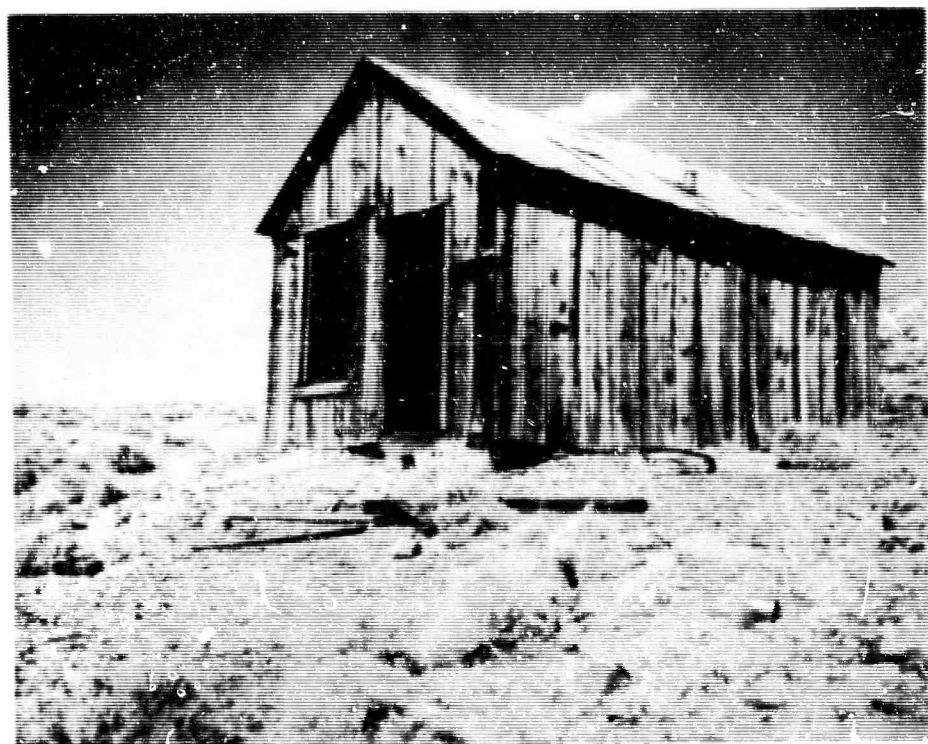
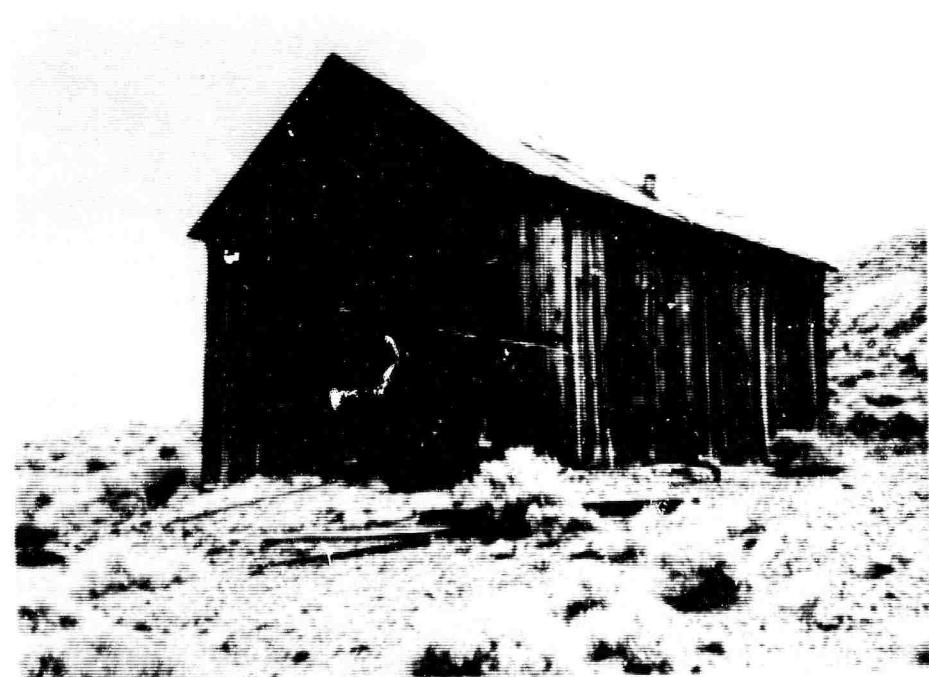
Photo No. 23-2 - Preshot - October 2, 1963

23-2 Shack (See photo 23-2) This 20 x 20-foot shack is wood frame and siding with corrugated metal roof. Siding weathered and warped. Doors and windows missing. No damage was noted as a result of the postshot survey.

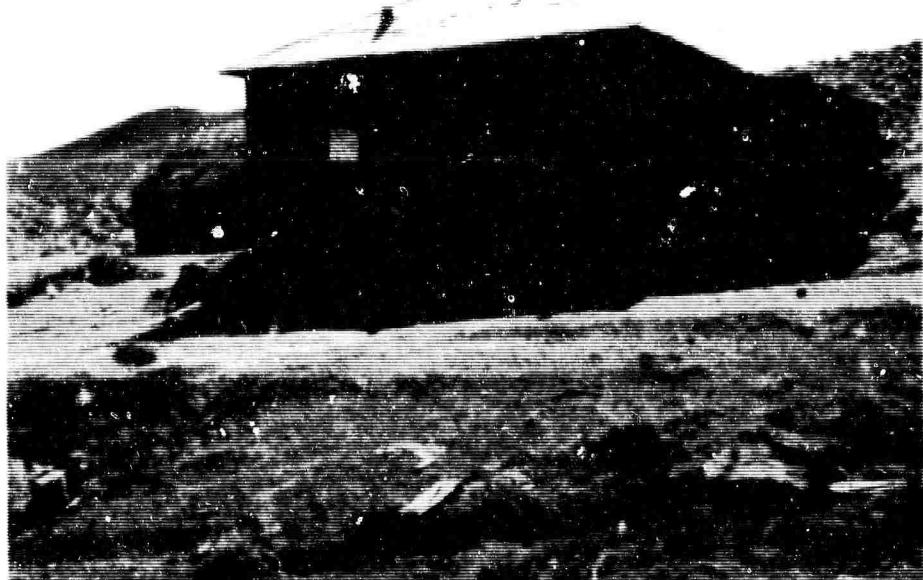
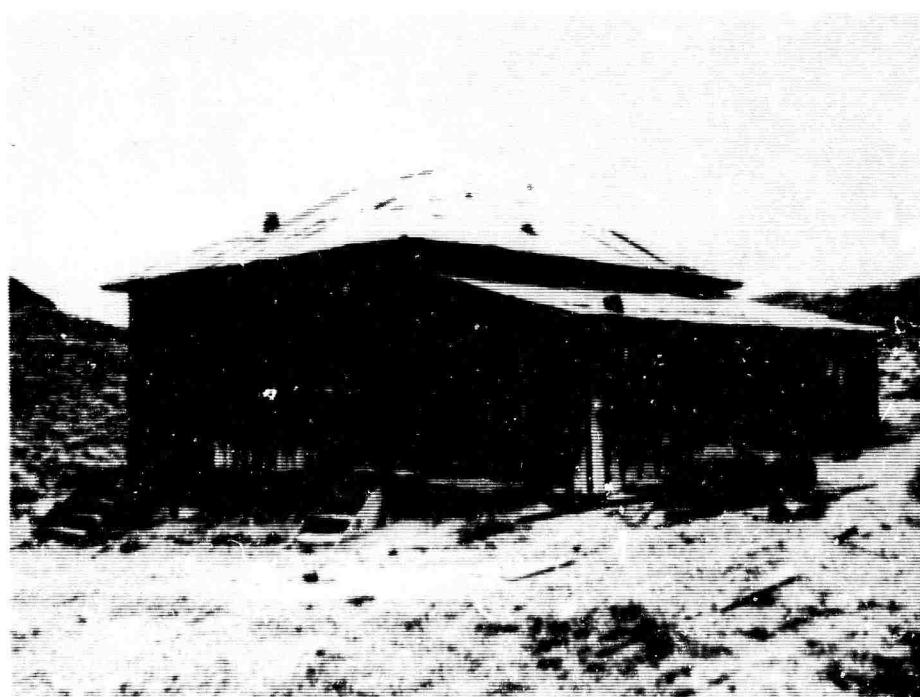
Photo No. 23-3 - Preshot - October 2, 1963

23-3 House (See photo 23-3) This 20 x 36-foot house is wood frame and siding with corrugated metal roof. Siding weathered and warped. Doors and windows missing. No damage was noted as a result of the postshot survey.

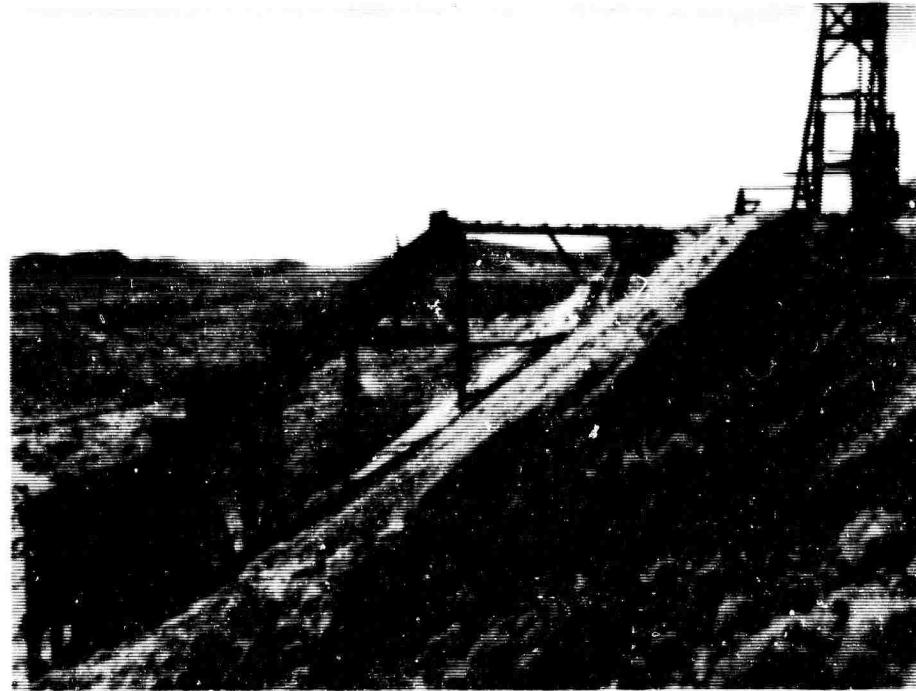
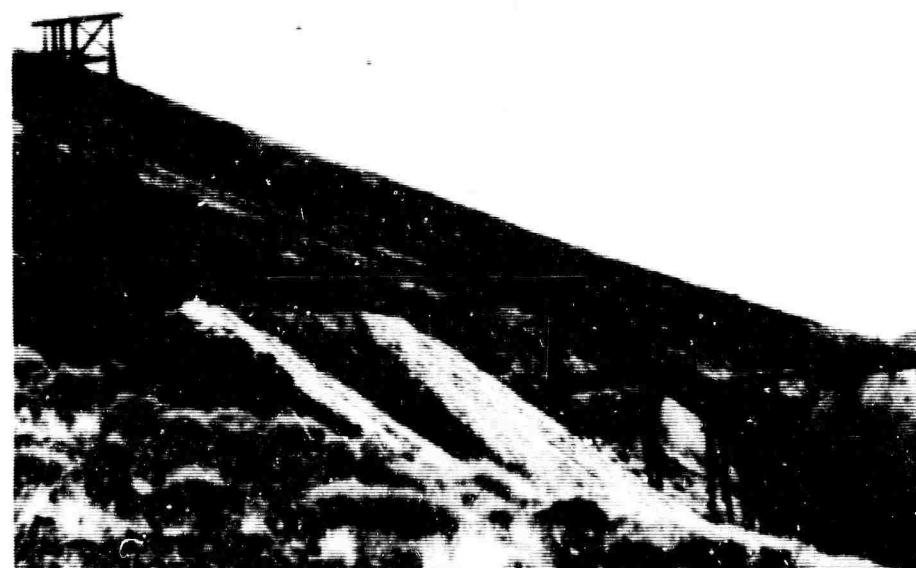
Photo No. 23-4 - Preshot - October 2, 1963

23-4 Headframe and Ore Bins (See photo 23-4) Headframe, tramway, and ore bins all of wood construction, all weathered. No damage was noted as a result of the postshot survey.

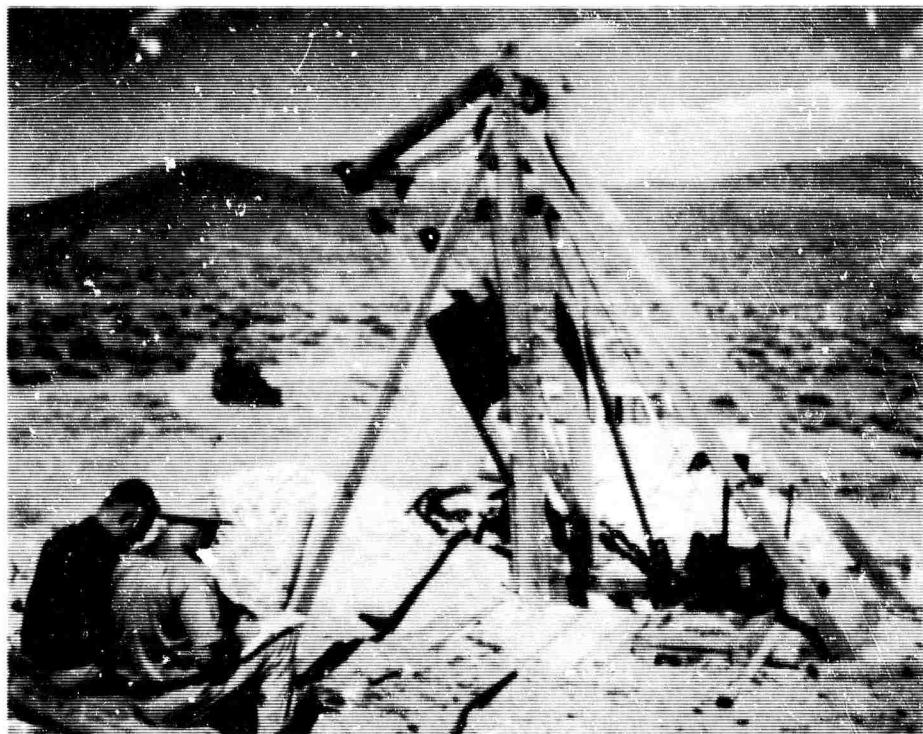
Photo No. 24-1 - Preshot - October 2, 1963

24-1 Headframe (See photo 24-1) Wood prospect headframe is the only structure on this site. No damage was noted as a result of the postshot survey.

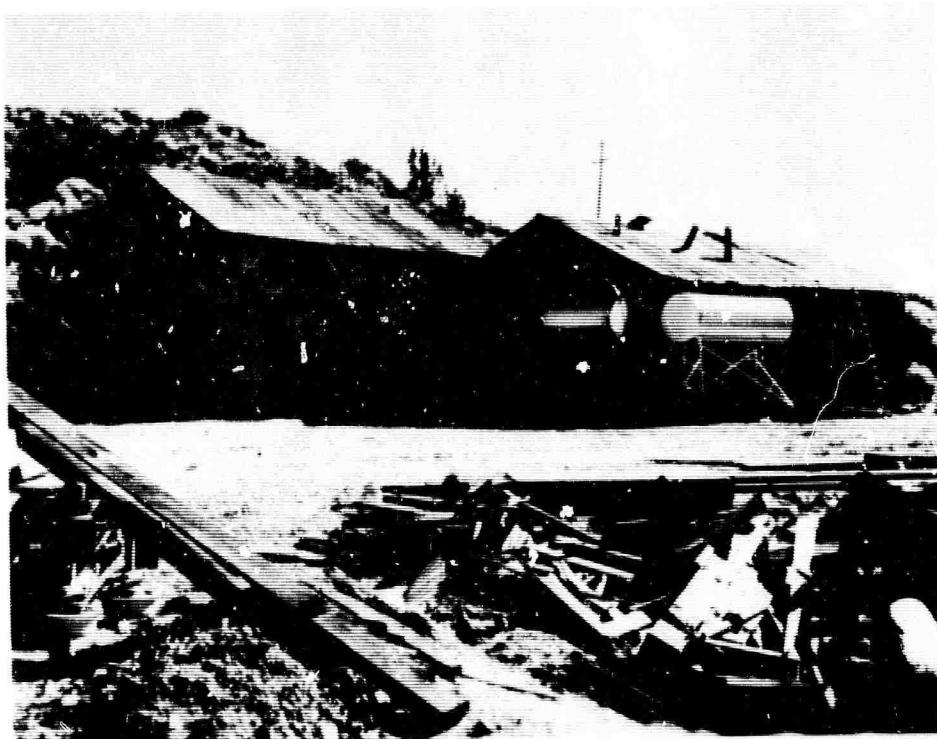
Photo No. 26-3 - Preshot - October 10, 1963

26-3 Hoist House and Generator Building (See photo 26-3) Hoist house and generator buildings of wood frame and corrugated metal roofing and siding. Structures have some siding missing. No damage was noted as a result of the postshot survey.

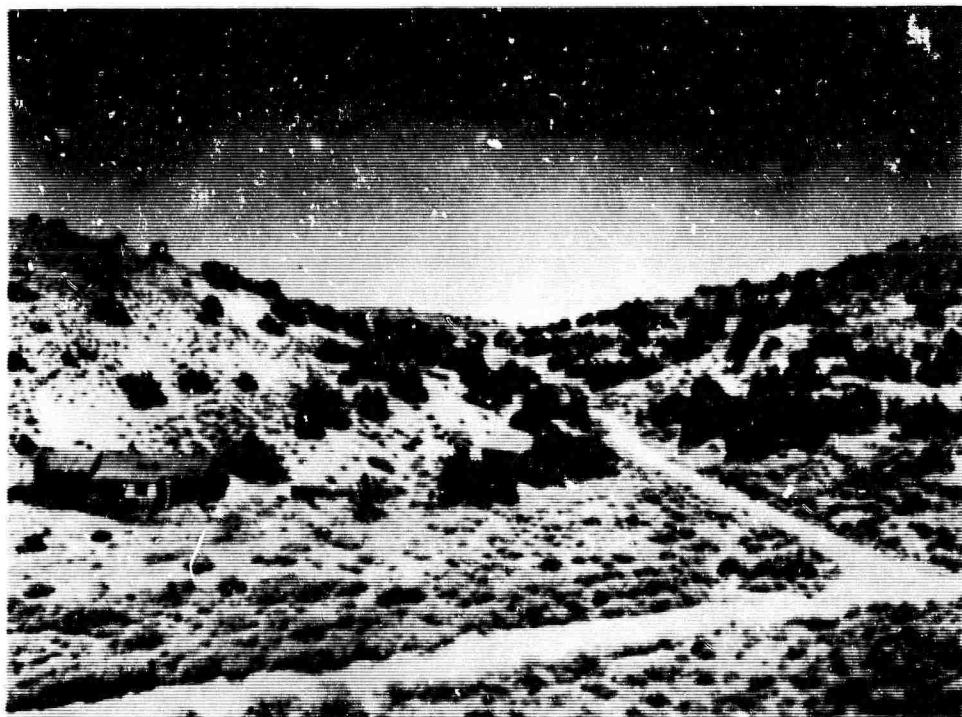
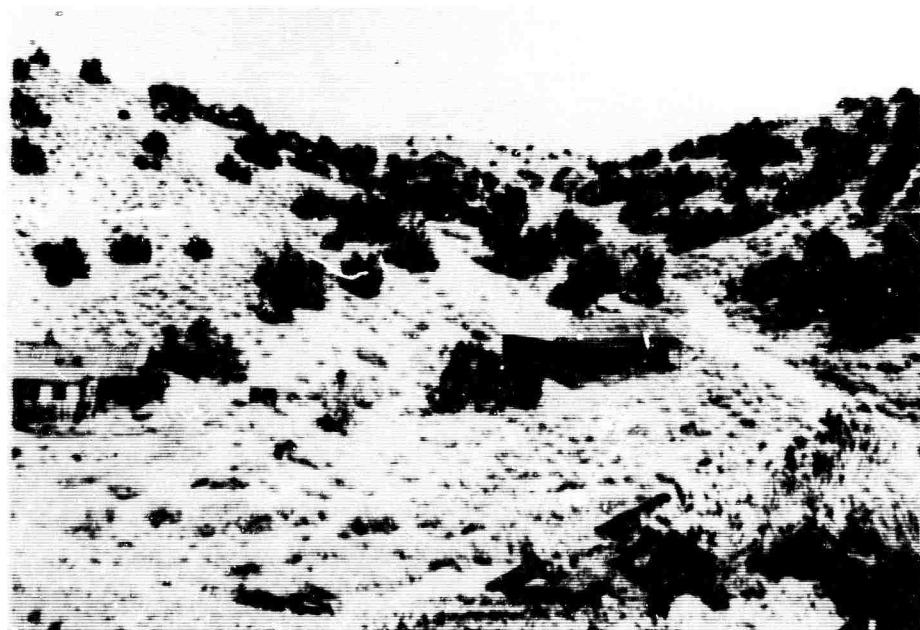
Photo No. 26-4 - Preshot - October 10, 1963

26-4 Camp Buildings (See photo 26-4) Abandoned, dilapidated camp structures of wood construction. Doors and windows generally are missing. No damage was noted as a result of the postshot survey.

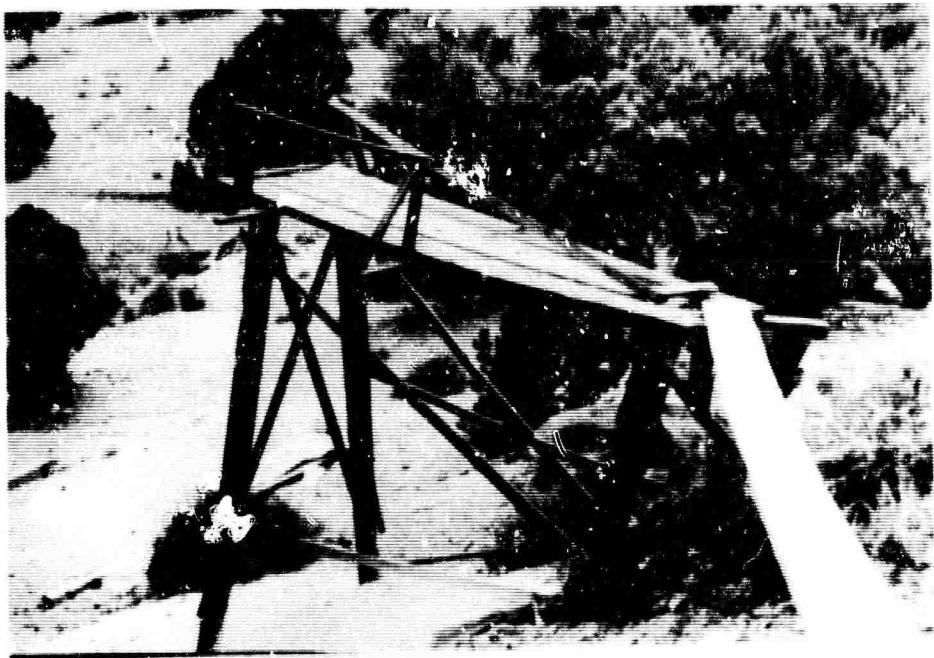
Photo No. 27-1 - Preshot - October 22, 1963

27-1 Trestle (See photo 27-1) Lower wooden trestle dilapidated. No damage was noted as a result of the postshot survey.
